City of Corpus Christi
Water Distribution System

Potential Backflow Incident

Progress on Backflow Incident

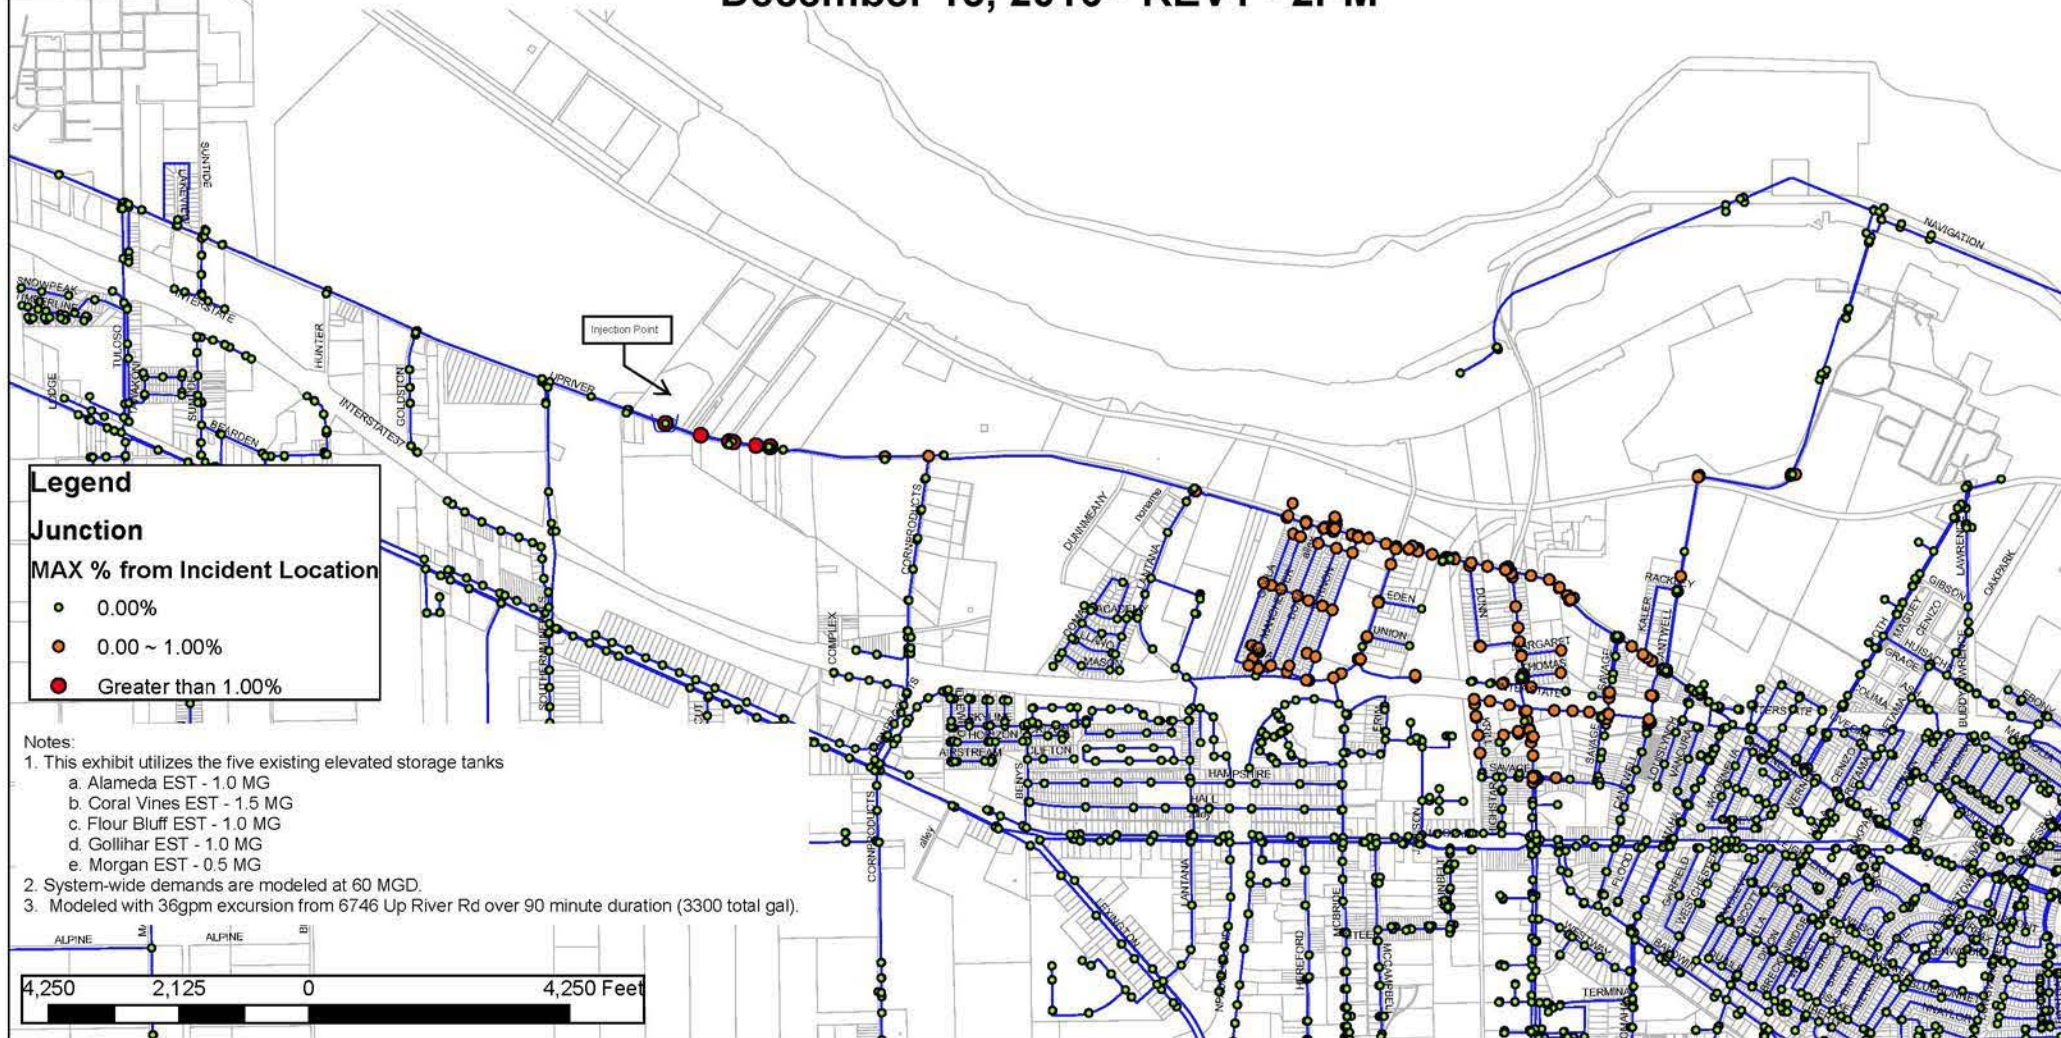
2016 City of Corpus Christi Water Distribution System Model 60 MGD 5-Day EPS Scenario Source Tracing Results - 6746 Up River Rd

- Computer program that simulates how water moves through the pipe network
- The best tool to predict a water systems behavior or its response to various emergency/operational scenarios
- The model was developed to introduce the contaminant at 6746 Up River Road (worst case scenario: 3,300 gallons over 1.5 hour period) and how it potentially moves through the system over the next 5 days

- Period simulation over a 5-day period
- 1% shown in legend of water model equals approximately 0.007% Indulin AA-86
- Hydraulic model shows zone of influence to be contained in the industrial area
